THE CONDOR

WHERE ENGINEER AND ORNITHOLOGIST MEET: TRANSMISSION LINE TROUBLES CAUSED BY BIRDS

By HAROLD MICHENER

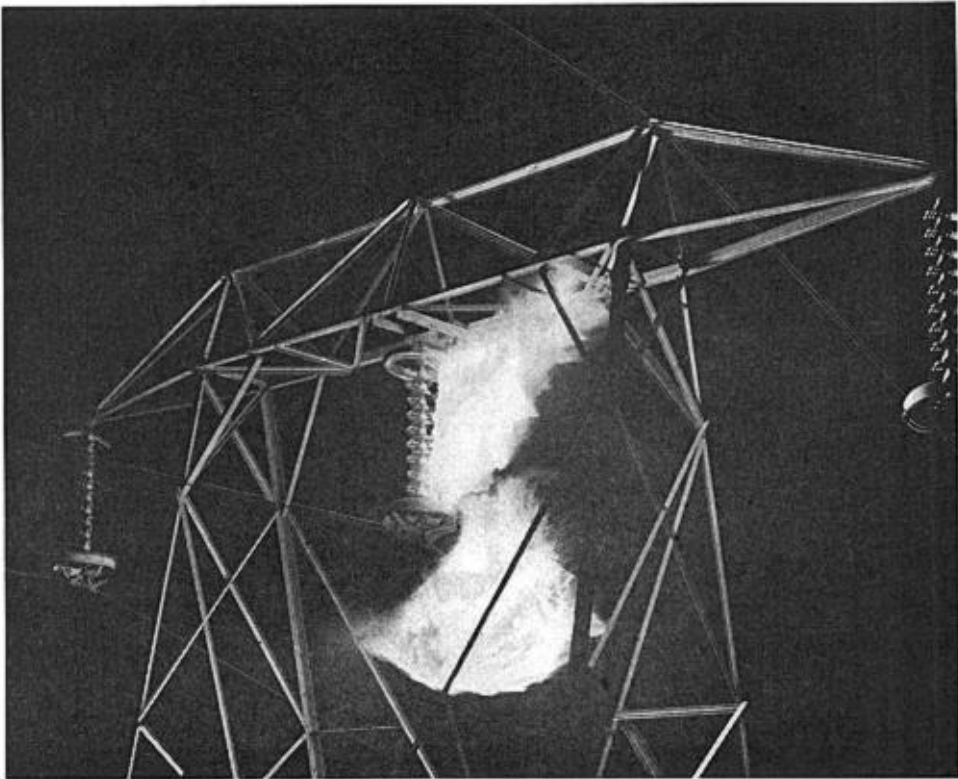
Fig. 63. TWO SEPARATE INSULATOR FLASHOVERS CAUSED INTENTIONALLY BY FINE WIRES. THE UPPER ONE IS TYPICAL OF THE CONCEPTION OF THOSE CAUSED BY BIRDS.

Figure 63 herewith shows two separate flashovers that were caused intentionally. The upper one was caused by dropping a fine wire from the tower to the lower shield ring and is of the supposed form of those caused by birds. In this case there was no wind to blow the arc across to the other side of the insulator string. On the next attempt the wire became detached from the tower above the

insulators and started the arc from the conductor to the tower members below it, causing the flashover as shown below.

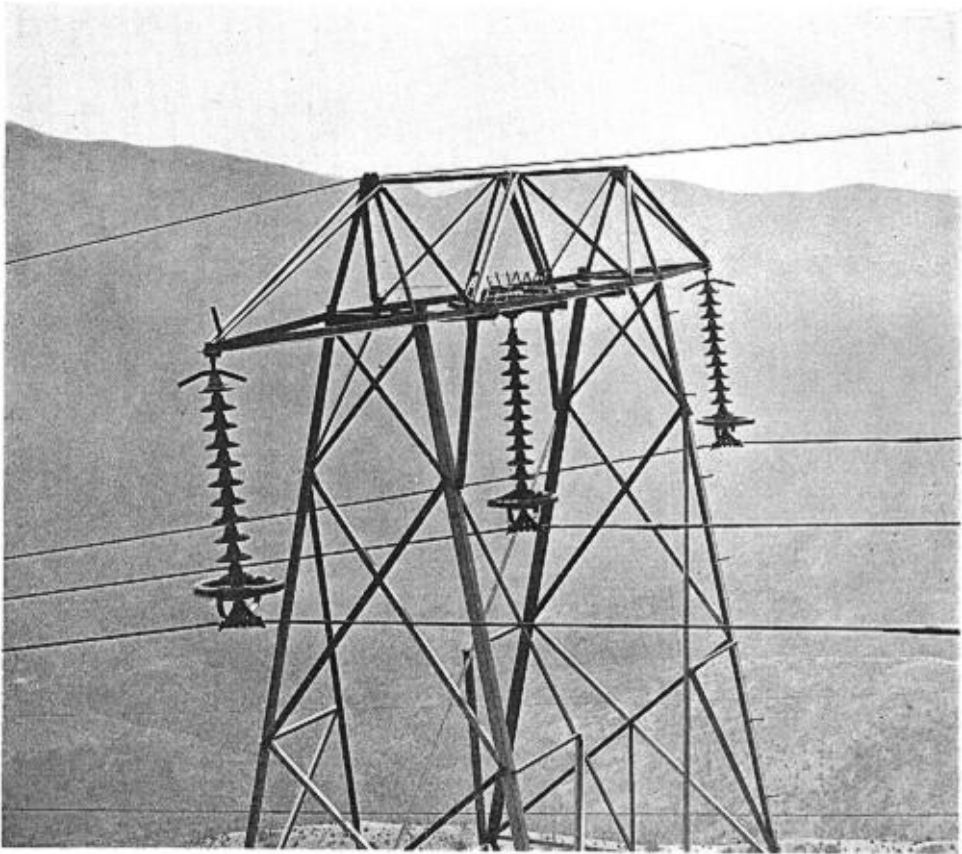
Fig. 64. BIRD GUARDS AS FIRST DESIGNED FOR THE 220000 VOLT LINES OF THE SOUTHERN CALIFORNIA EDISON COMPANY. THIS WAS PRIMARILY AN ATTEMPT TO KEEP THE LARGE RAPTORES FROM ROOSTING ABOVE THE CENTER STRING OF INSULATORS.

Since the greater number of flashovers occurred over the center insulators, the first attempt to keep the birds away consisted of placing an inverted "V" grillage of steel straps on the tower members which supported these insulators, and which formed the favorite roosting places, and in stretching heavy wires about four inches above the other horizontal members for a distance of four or five feet on each side of the center. Also above each outside insulator string, a single spike was placed so that it interfered with a large bird perching there. (See fig. 64.) These guards were put on the greater part of the lines during May and June, 1923, but the flashovers, instead of decreasing in number, increased appreciably. The indications were that the birds, having been forced out of their accustomed places, were perching on the top shield ring of the center insulators and thus causing more trouble than before. This top shield ring was made of a one-fourth by two inch steel strap, was twenty-seven inches in diameter and was placed around the top of the insulator. (See fig. 65.) They were removed during September, October and November of 1923, and the number of flashovers decreased considerably, but still continued at a lesser rate partly due to the persistence of the birds in crowding into their old roosting places, and partly to the fact that no guards had been placed on the towers in some of the less troublesome parts of the line.

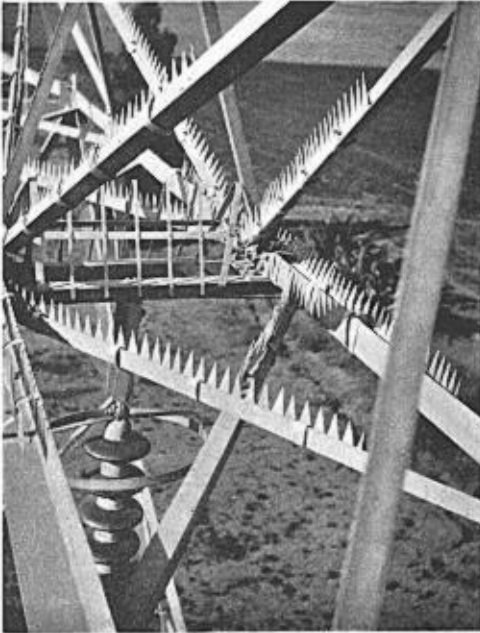
65

Fig. 65. ANOTHER STAGE IN THE DEVELOPMENT OF BIRD GUARDS AROUND THE SUPPORT OF THE CENTER STRING OF INSULATORS. EVEN THIS ARRANGEMENT WAS NOT ENTIRELY SUCCESSFUL IN KEEPING THE BIRDS FROM ROOSTING THERE.

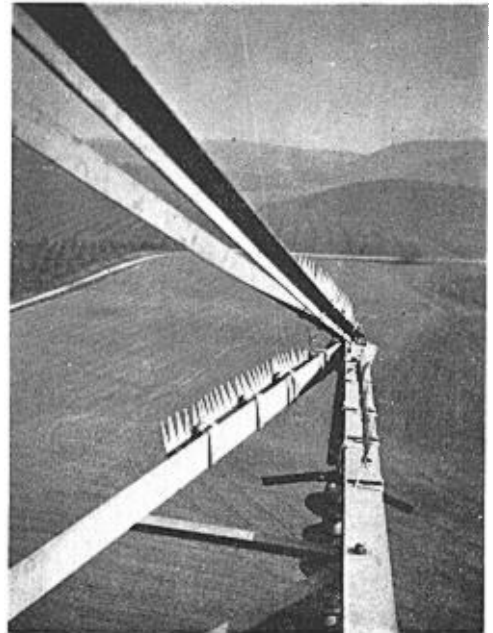
66

Fig. 66. SAW-TOOTH BIRD GUARDS AT OUTER INSULATOR SUPPORT.

These bird pans seemed to be effective in stopping the flashovers on the center insulators, but they were expensive, costing about \$12.00 per tower, and they did not give any protection to the outer insulators. To meet these objections, saw-tooth guards were cut in four-foot strips from thin sheet iron. These, ^{to}teeth were about three inches long and one and one-half inches from point to point. These were held to the tower members by sheet iron straps. (See figs. 65 and 66.) They were first placed on all the horizontal members of the tower top for a distance of four feet to the side of the insulator supporting points on a considerable portion of the towers which were not already equipped with the pans. They helped but did not prevent all of the flashovers. Some of the evidence showed that birds perching more than four feet to the side of the insulator supports were sometimes

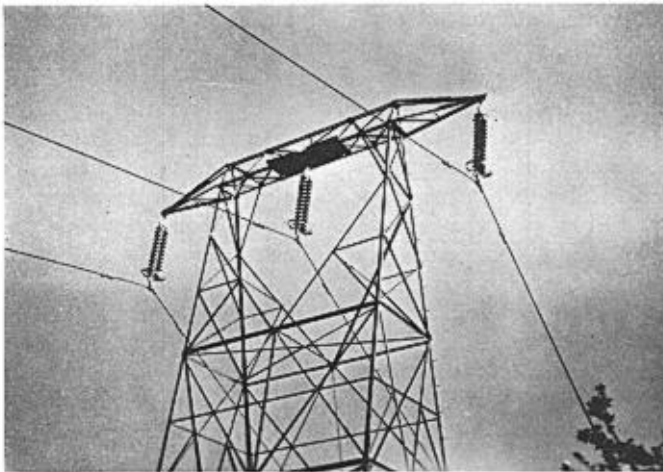
Fig. 67. LATEST DESIGN OF BIRD GUARD ON 220000 VOLT LINES OF SOUTHERN CALIFORNIA EDISON COMPANY. A SHEET-IRON PAN ABOVE CENTER INSULATORS AND SAW-TOOTH GUARDS ABOVE OUTER INSULATORS. BECAUSE OF THE LARGE VERTICAL ANGLE ON THIS TOWER, DOUBLE INSULATOR STRINGS ARE USED.

After many months trial, it was decided that the saw-tooth guards by themselves were not good enough and that all the towers should be equipped with the bird pans over the center insulators and with saw-tooth guards on the ends of the cross-arm to a point six feet from the outer insulator supports. (See fig. 67.) This has been done, with beneficial results on the parts of the lines where the Raptores are most common; and when the remainder of the lines are so equipped it is expected that a flashover will be a very rare occurrence, though they probably will not be stopped entirely. It is known that Sparrow Hawks sometimes perch on the upper parts of the insulator and that Herons and the larger Raptores may sometimes perch on the outer ends of the cross-arm in spite of the saw-teeth. Although the mileage of 220,000 volt lines has been increased about fifty percent, the means employed for protection from birds has reduced the numbers of flashovers from those cited above to less than one per month. This gives a measure of the results obtained.
