DAMAGE BY GOLDEN-FRONTED AND LADDER-BACKED WOODPECKERS TO FENCE POSTS AND UTILITY POLES IN SOUTH TEXAS

JOHN V. DENNIS

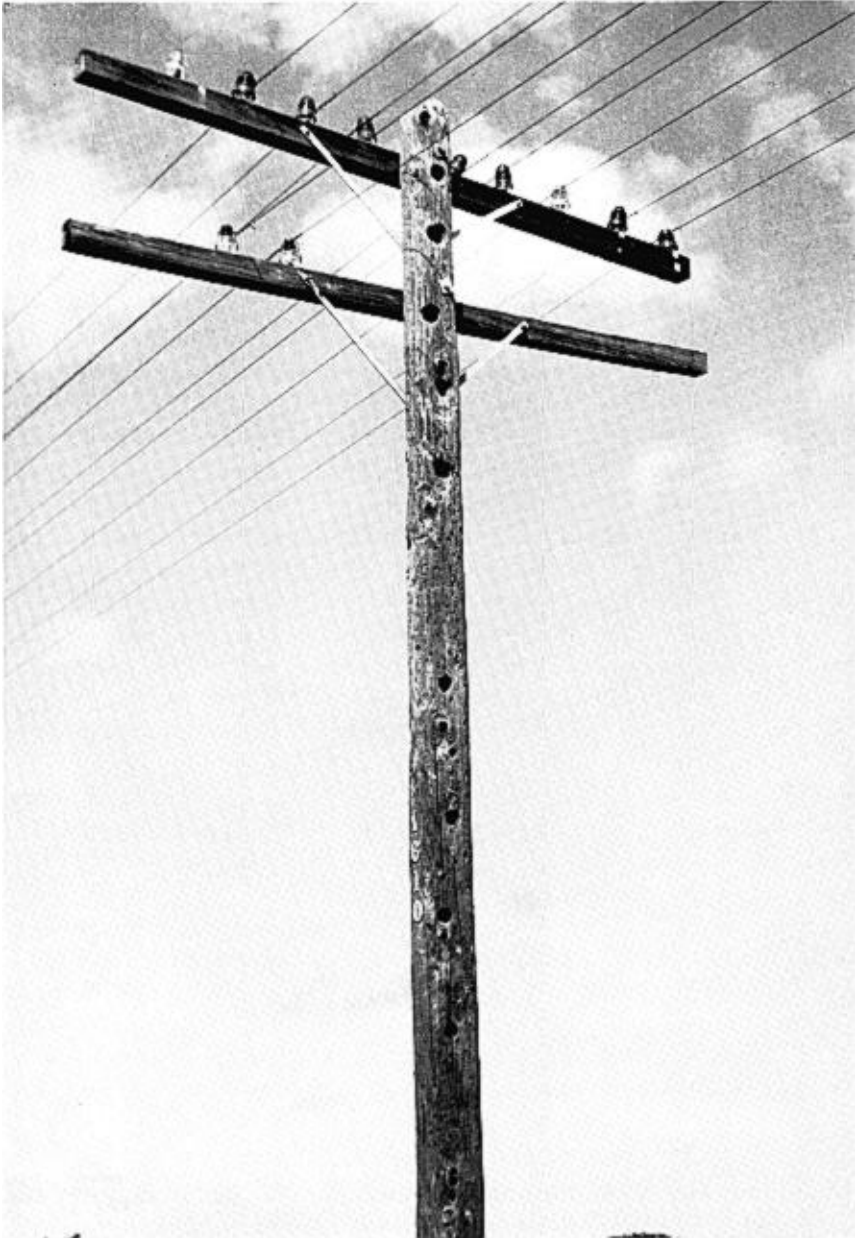
FIG. 2. Distribution of holes on this telephone pole is typical of Ladder-backed's work. Heaviest attack is near the top of pole. A few holes are found on the lower portion and beginning almost from the ground level.

Attack on utility pole structures by the Ladder-backed is characterized by heavy damage to crossarms and braces, and frequent heavy damage to the top 2 or 3 feet of the pole. Damage sometimes extends from ground level to the top of the pole (Fig. 2). Attack on crossarms and braces always originates on the underside, never the sides or top. Typically, a crossarm is drilled at a site on the underside from 6 to 18 inches from the end. The purpose of this drilling is apparently the excavation of a roosting or nesting hole. Rarely are these holes completed. Often the bird "misjudges" the dimensions of the crossarm and breaks "windows" in one or both sides, or breaks a hole in the top. In other cases, the bird appears to tire of its work and discontinues after drilling only an inch or two. In the rare instances that a cavity is completed, the tunnel always leads from the entrance toward the pole—never away from the pole. Completed cavities in crossarms are from 6 to 10 inches in length.

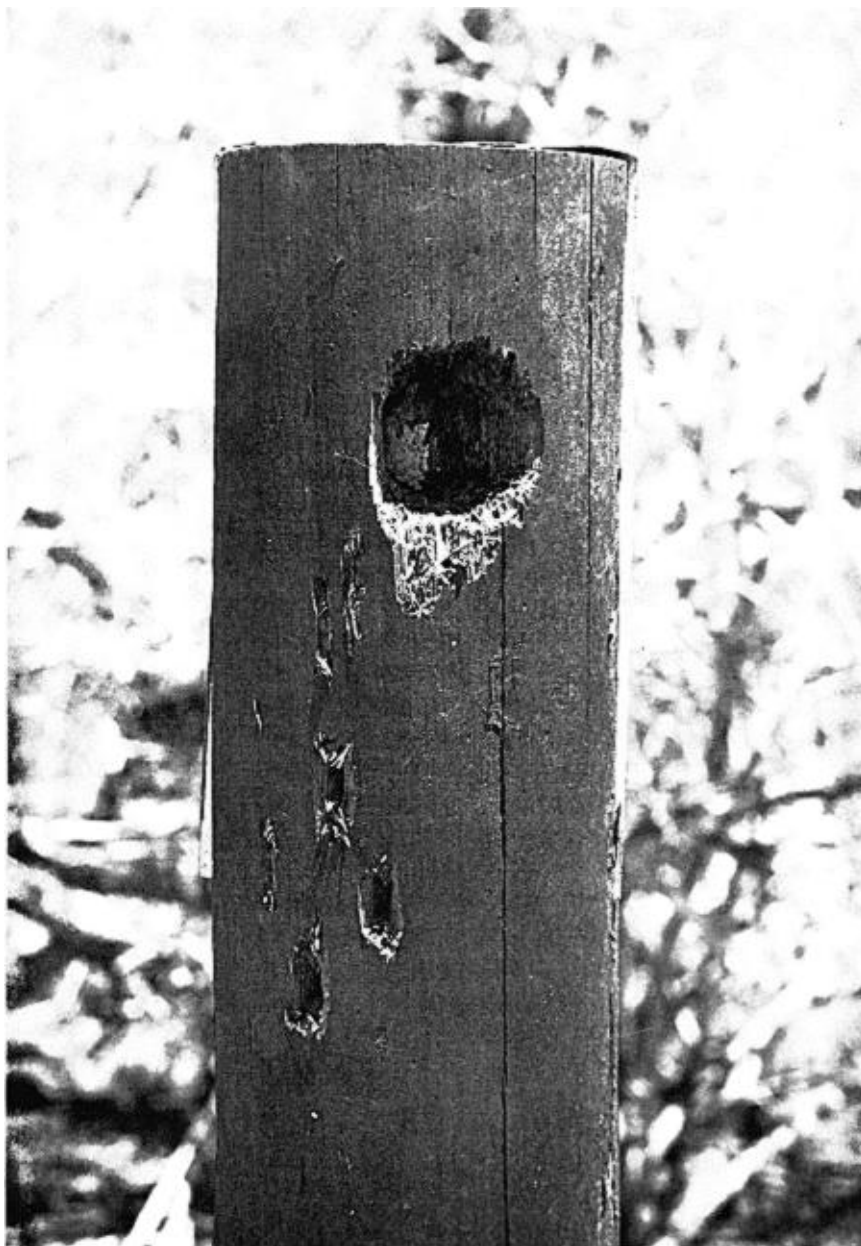
This tendency to attack locations opposite metal attachments was tested on a small scale in fence post experiments at the Laguna Atascosa Refuge. A slit 5 inches deep was sawed into the top of 10 creosoted pine fence posts. A 5-inch square of sheet metal was inserted into each slit. Posts containing the hidden metal plates were placed in test strips with 30 unaltered creosoted pine fence posts. As with the other test posts, placement was made in late February and posts were checked in late April. Of the 30 unaltered posts, six (20 per cent) had been attacked; of the 10 posts with metal plates, seven (70 per

FIG. 3. A flat metal plate has been inserted into a groove cut into the top of this creosoted pine fence post. A woodpecker has drilled a hole to the plate. Small holes are scattered about near the large hole.

cent) showed attack. Figure 3 shows attack at a post with a hidden metal plate.
