DEATH BY MISADVENTURE  
By Constance Katholi

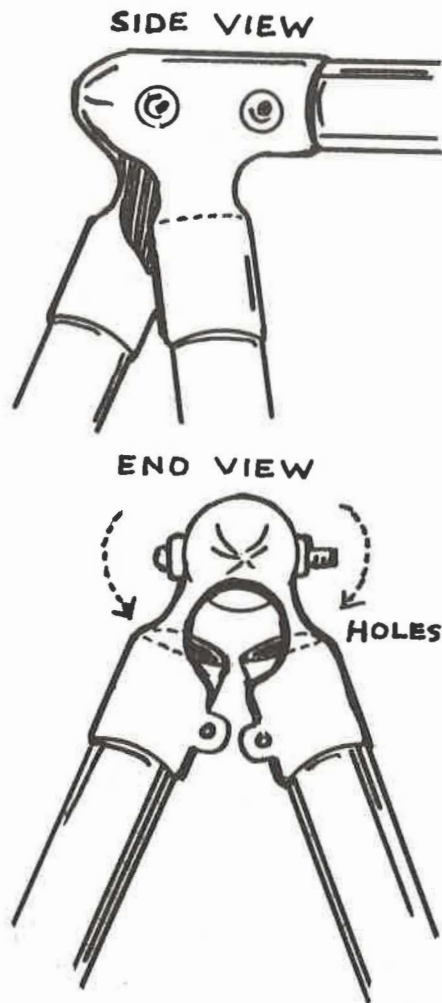
This particular outfit which has numerous adaptations for swings, rings, and a slide is not a home-made affair but a standard product. The apparatus consists of four open-ended steel tubes, each  $2\frac{1}{4}$  inches in diameter, forming a pair of "A" frames, which support a sealed horizontal member to which the swings, etc., are attached. (See accompanying diagram.) The holes at the top of the "A" frames invite curious, shelter-seeking birds to enter--those birds which would use nesting holes anyway--and on proceeding down the diagonals, whether by intent or accident, are unable to retrace their path.

Unfortunately, the holes at the top of the frame were not immediately plugged with rags or paper--as they are now. This is a simple home remedy to be sure, but one which should not be necessary if the outfit had been properly designed in the first place. How many of these swings are currently in backyards and playgrounds all over the country?

A little publicity on this subject, coupled with an appeal to manufacturers to cap the hollow tubes in the factory, could save many birds in the future.
