DAMAGE BY GOLDEN-FRONTED AND LADDER-BACKED WOODPECKERS TO FENCE POSTS AND UTILITY POLES IN SOUTH TEXAS

JOHN V. DENNIS

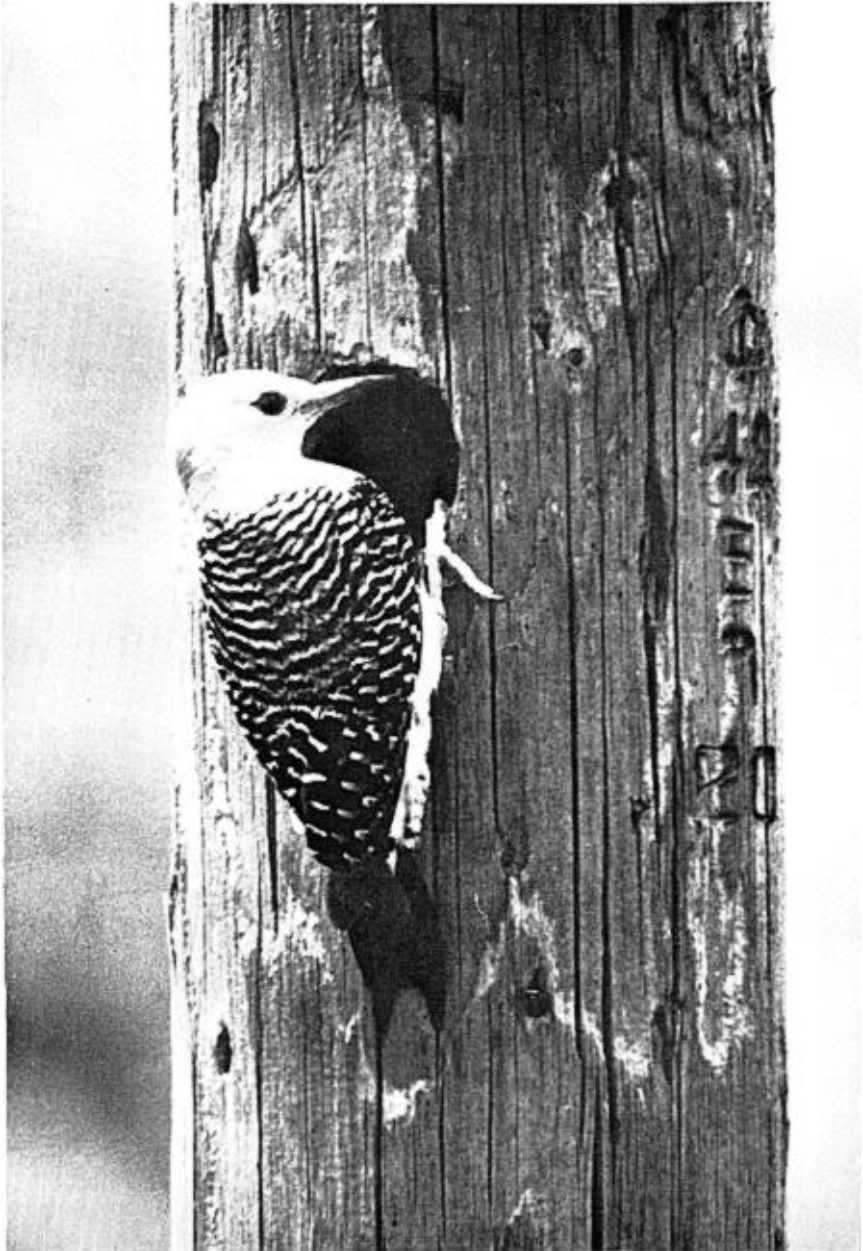
FIG. 1. Female Golden-fronted Woodpecker at nest hole in a small electric distribution pole. Hole is about six feet from the ground.
